August 31, 2009

Volunteer Fire Lieutenant Killed While Fighting a Basement Fire - Pennsylvania

Fatality Assessment and Control Evaluation Investigation Report # F2008-08

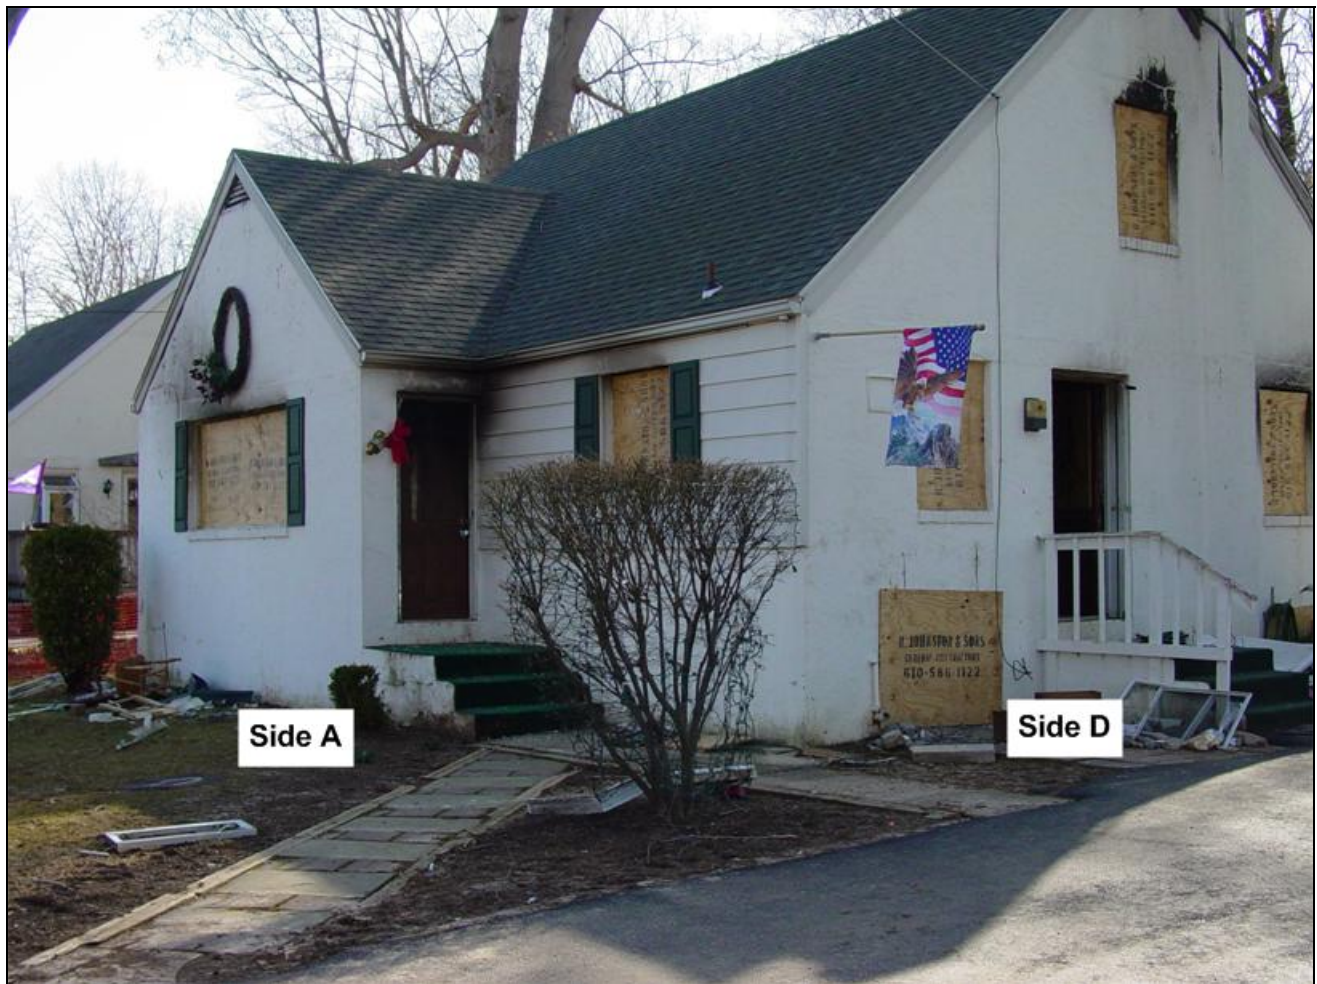
The fire building was a 2-story, single family residence constructed in 1956 (see Photo 1). The building style was Cape Cod, and was constructed with cinder blocks covered with stucco. The structure had an A-frame roof covered with asphalt shingles. The structure had a full basement which had been divided in half by a wall comprised of wooden studs covered with wood paneling. The basement area where the incident occurred, a 14-foot x 16-foot sitting room, was the first room located at the bottom of the stairway landing. The room was furnished, had wood paneling on the walls, a suspended drop ceiling constructed of 2-foot by 4-foot acoustical panels, and the floor was

Photo 1. A and D-side of fire structure.
NIOSH photograph.

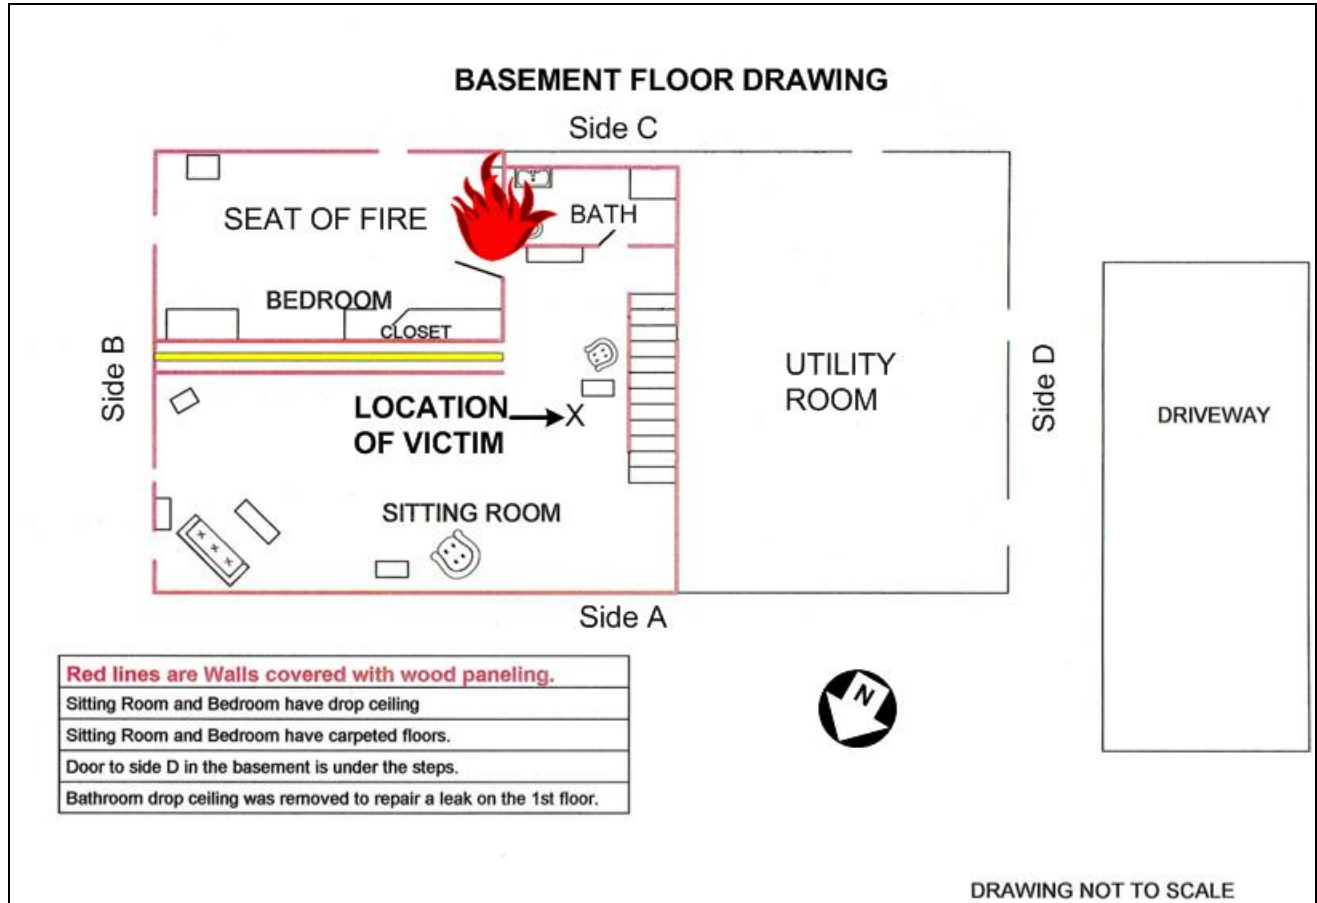
carpeted (See Diagram 1-basement floor drawing). *Note: The seat of the fire was reported to be behind the computer on the D-side wall of the basement, and the fire was electrical in nature.*

Diagram 1. Basement floor layout.
Diagram created from drawing provided by fire marshal's office.

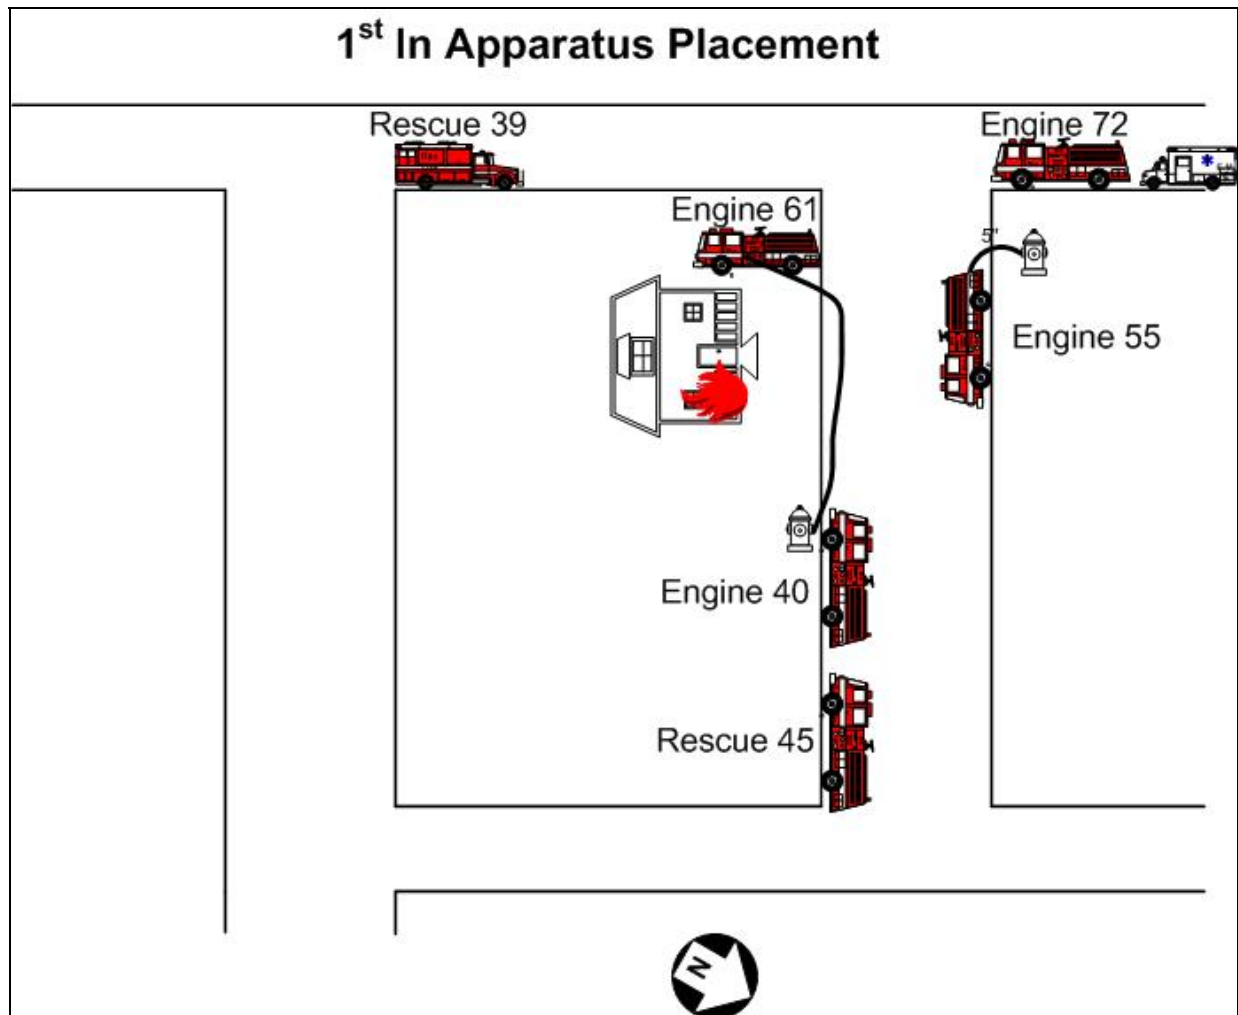
(See Apparatus placement diagram)

Diagram 2. First-in apparatus placement.
Diagram created from drawing provided by fire marshal's office.

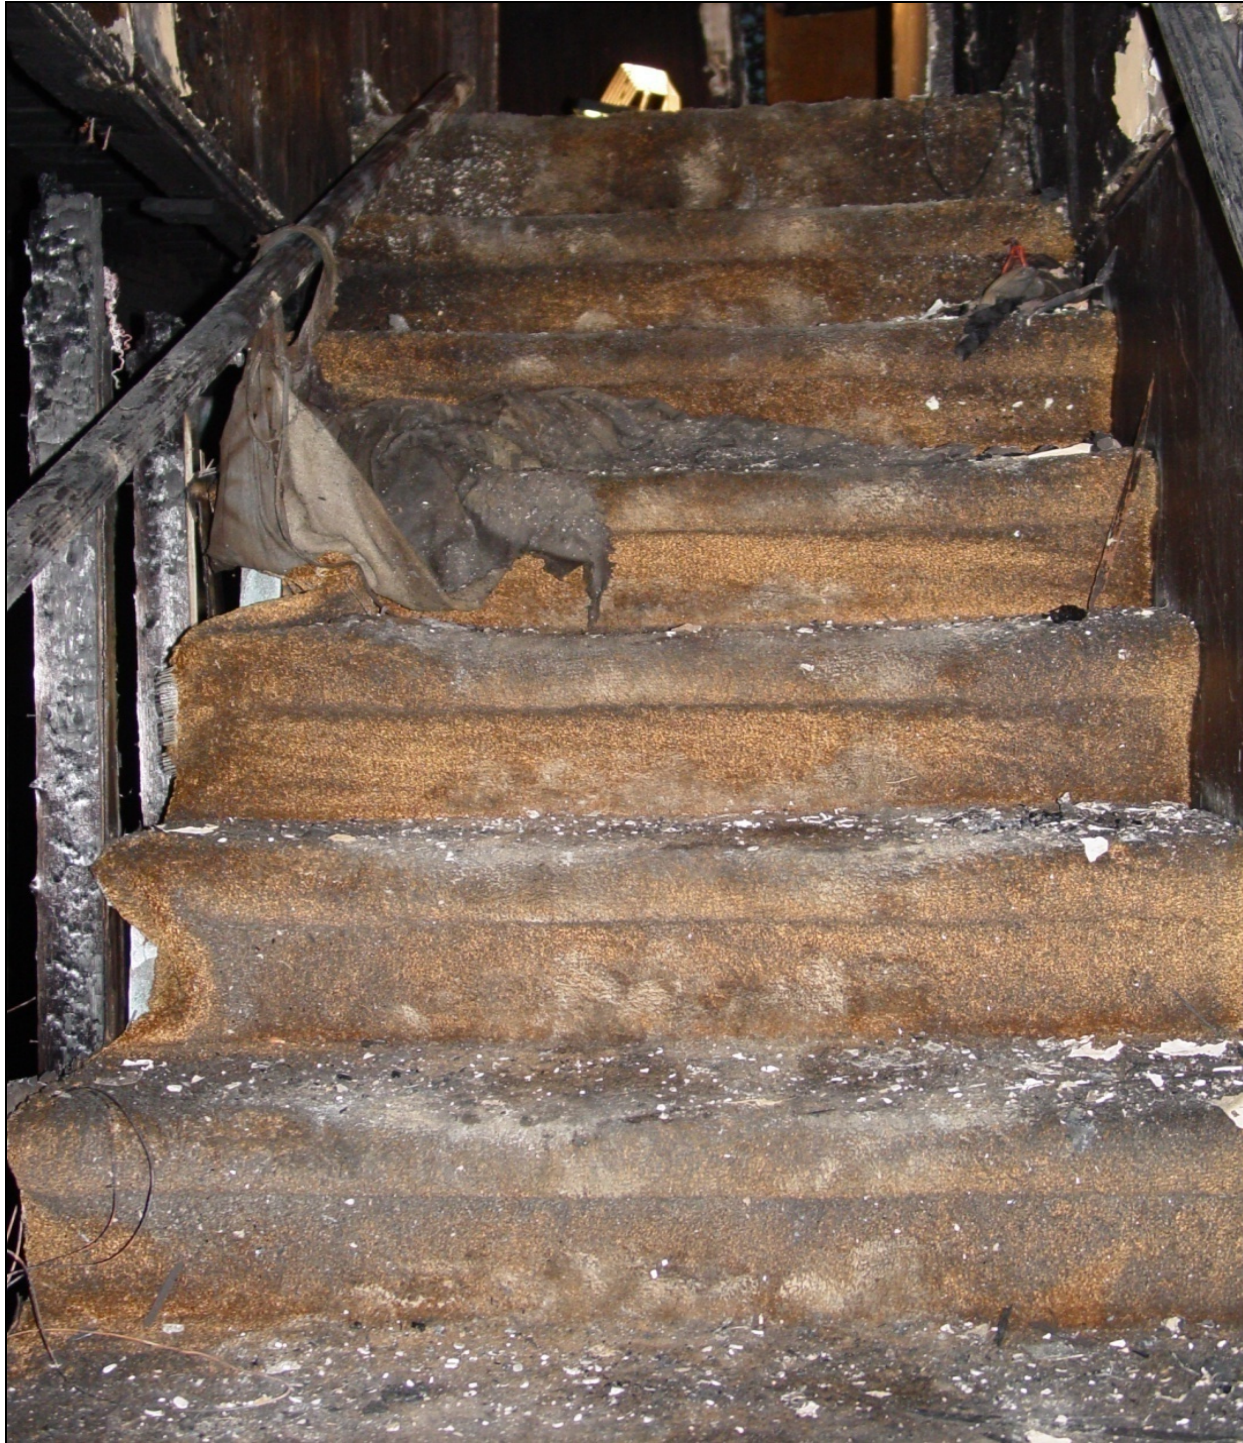
Photo 2. Stairway leading from 1st floor down into the basement.
NIOSH photograph.

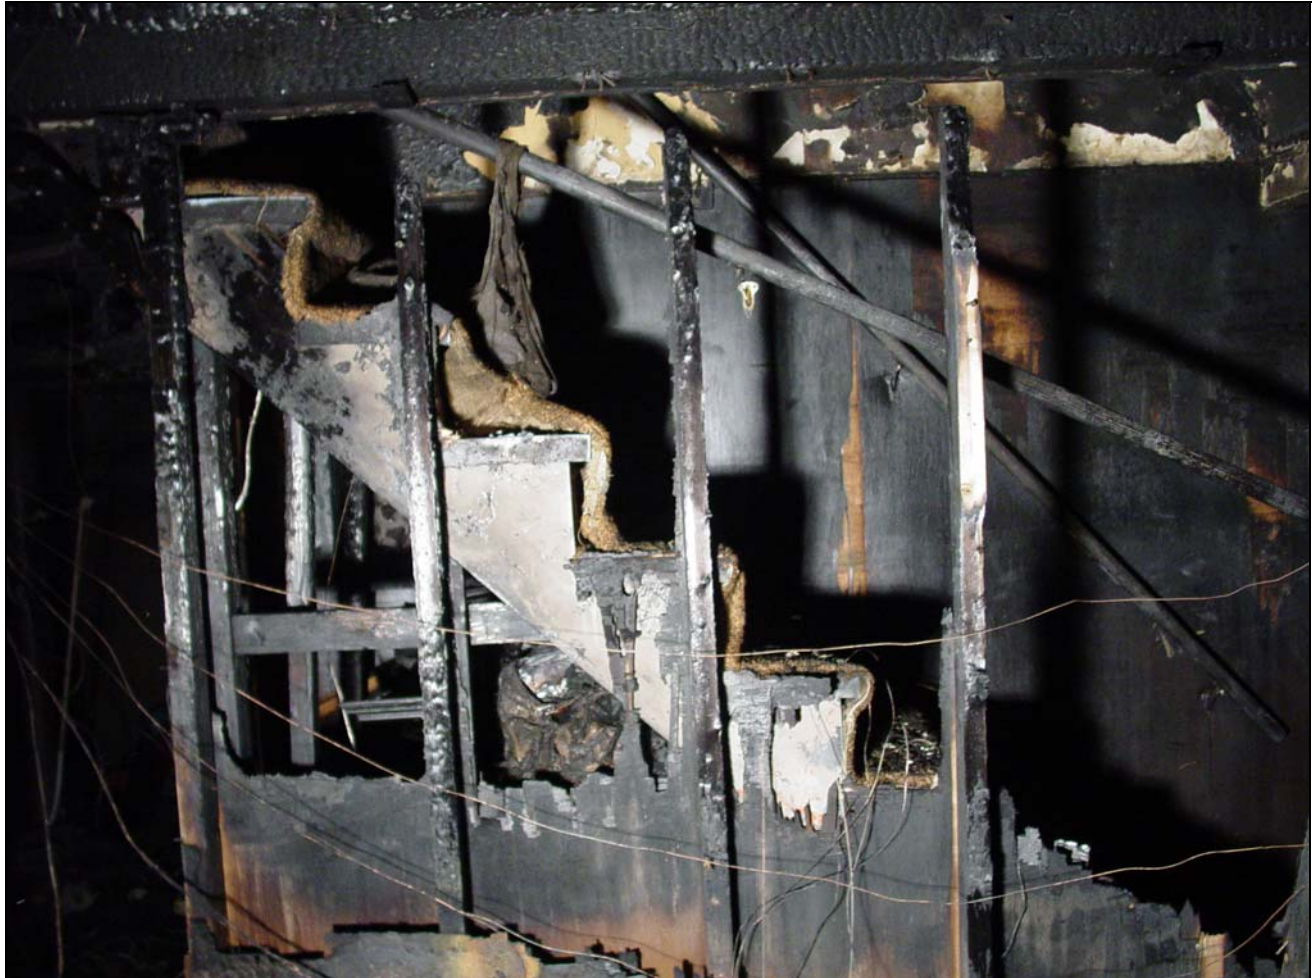
Photo 3. Side view of stairway leading from 1st floor down into basement.
NIOSH photograph.

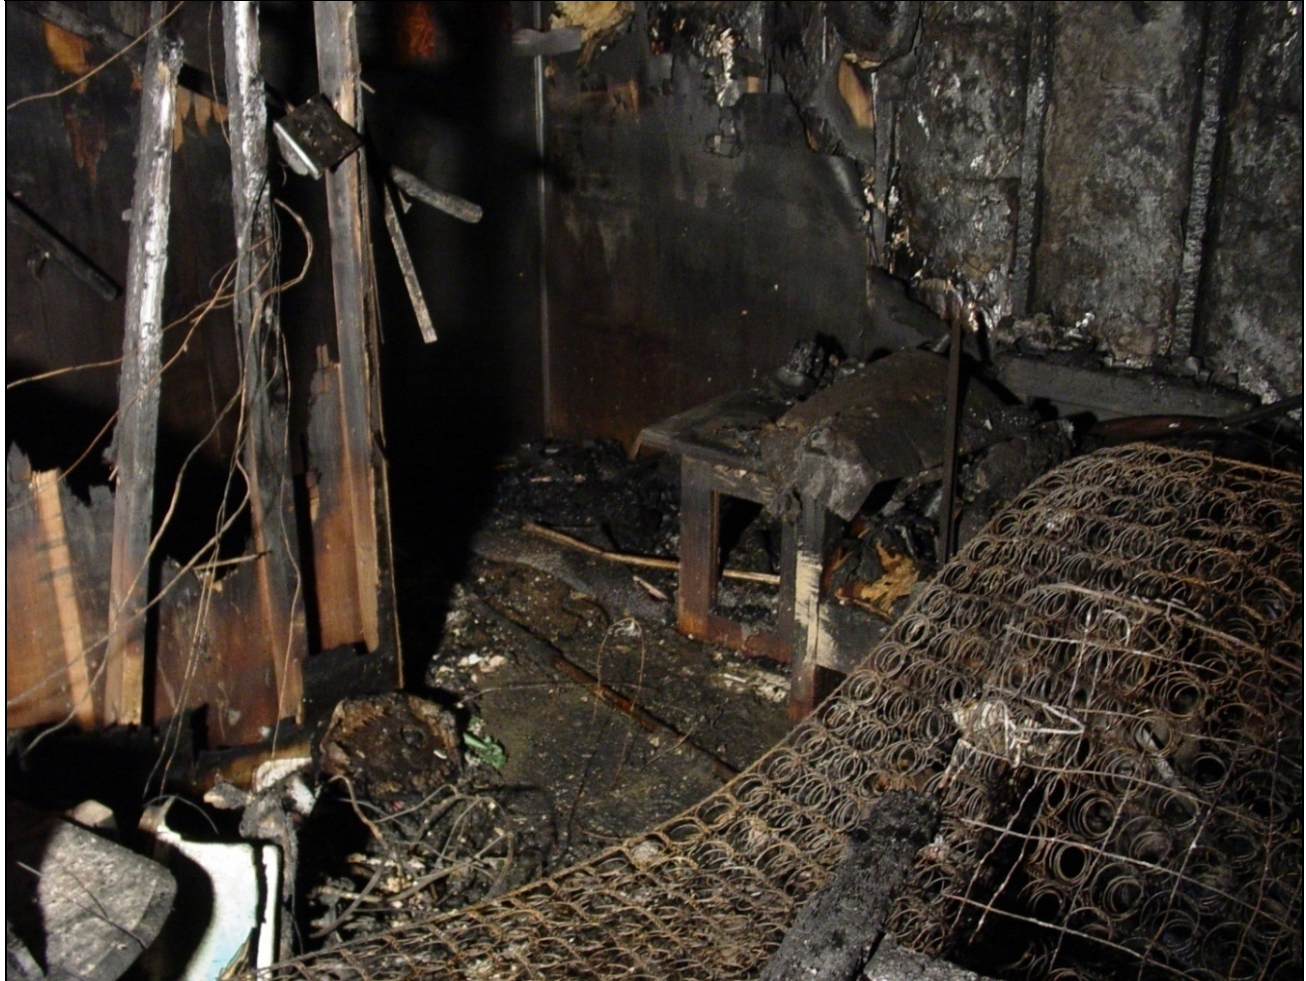
At 0930 hours, the 2nd RIT found the victim with the aid of a Thermal Imaging Camera and the sound made by his PASS device. He was about 6-8 feet from the bottom of the stairway (see Photo 4), but due to several of the RIT fire fighters SCBAs running low on air because of the extended time of the rescue attempts, the fire fighters had to exit. A 3rd RIT entered the structure and reported that the 1st floor conditions were deteriorating. Smoke, heat, and fire were making it unsafe for any rescue from the stairway connecting the 1st floor and basement. The 3rd RIT advanced down the stairway to the basement and located the victim. He was found on his left side in approximately 3-4 inches of water. His helmet and SCBA mask were on, but his gloves and hood were not. The victim was not trapped or entangled. A decision was made to remove the victim through the basement window on the A/B corner. The basement window was enlarged using a saw, and a ground ladder was placed through the basement window into the basement. A 4th RIT entered the structure and went down the stairway to the basement. They helped place the victim on the ground ladder. At about 0937 hours, a rescue rope was attached to the victim and he was slid up the ground ladder to the outside where emergency medical personnel waited (see Photo 5). The victim was transported by ambulance to the local medical center where he was pronounced dead at 1035 hours. During the rescue attempts, four fire fighters received minor injuries. They were treated at the local hospital and three were released that day while one required hospitalization for another day.

Photo 4. Approximate area in basement where victim was located next to stairway.
NIOSH photograph.

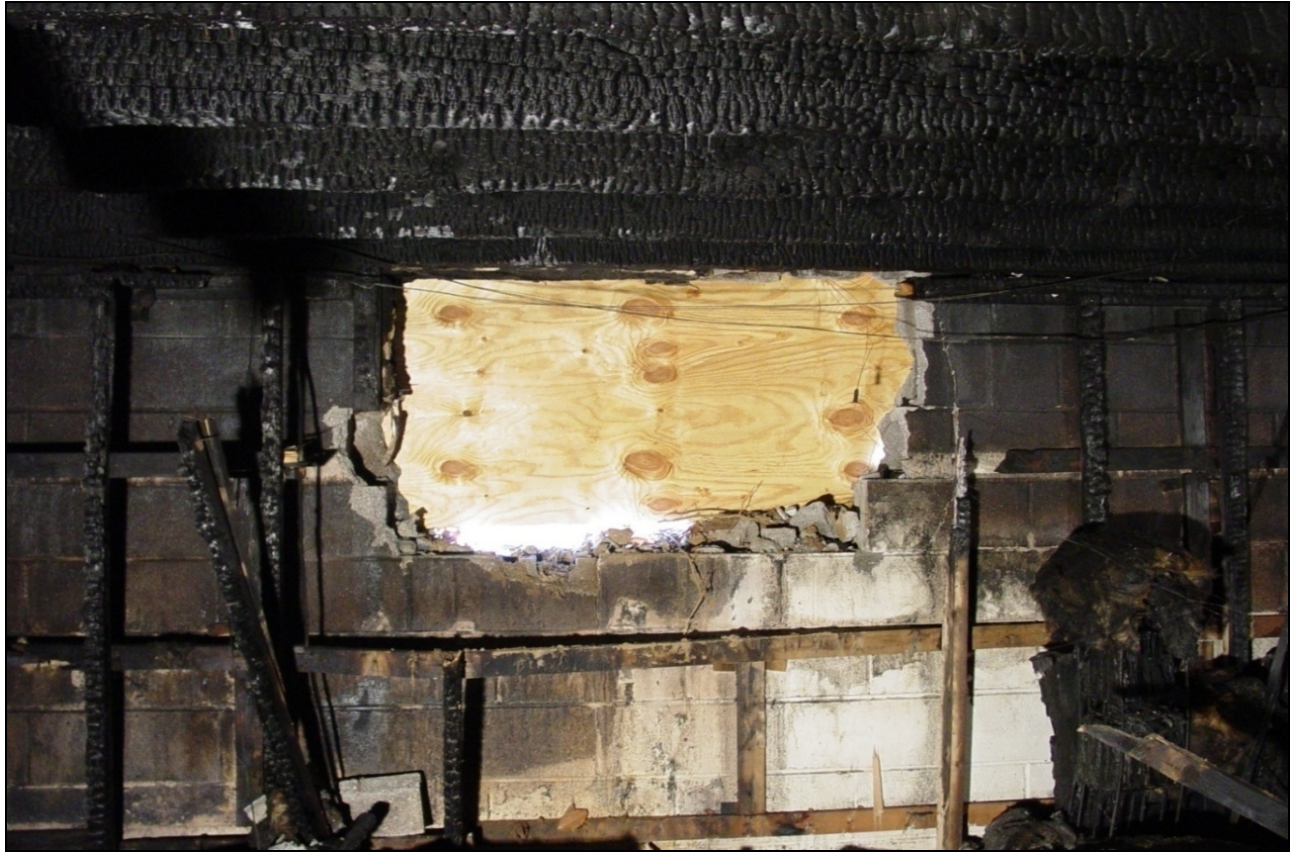
Photo 5. A/B corner basement window where victim was eventually removed.
NIOSH photograph.
